# Manhole Inspection Summary

# Manhole # S41I\_\_016MH

Insp Date: **5/14/08 12:00 PM**

**Location** Address: **250 gough st**

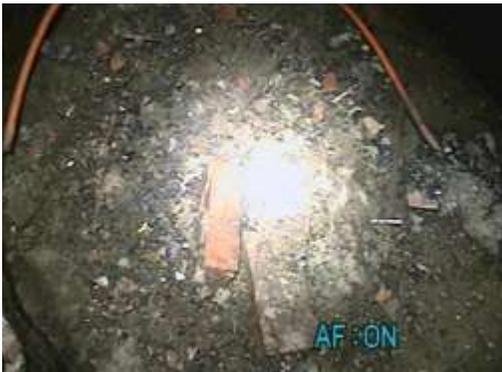
Defect 2

Condition:  Sound  Cracked  Root Intrusion  Deteriorated  Leaks  **Debris**

channel debris

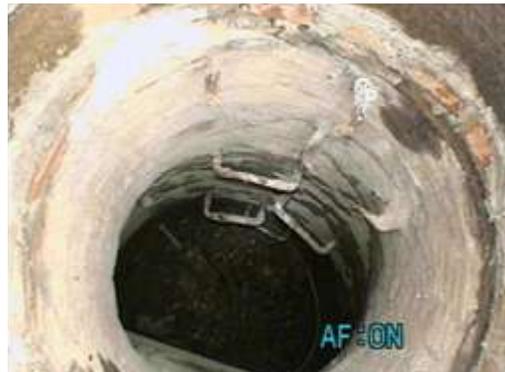
Defect 1

Condition:  Sound  **Cracked**  Root Intrusion  Loose Brick  **Deteriorated**

Infiltration:  None  **Joint**  Cracks  Mortar  Roots  Wall

Infiltration:  None  Joint  Cracks  Mortar  Roots  **Wall**

**Steps** Count: **6** Missing: **1**  **Corroded**

missing/corroded steps, cracked and deteriorating corbel, infiltration from corbel joint & barrel wall

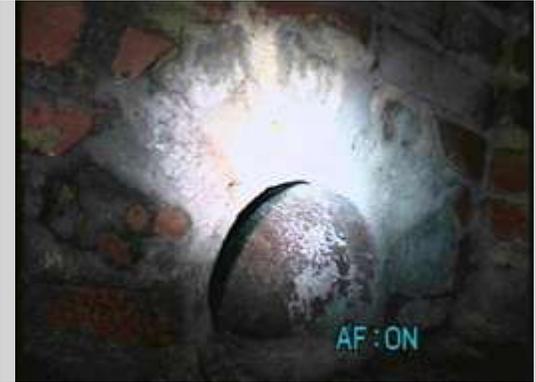
12 O'Clock Outflow

12 pipe is to far under mh shelf to get a better shot
